Inspection Report

191 Example St. Halifax

Look over a new Composite deck built on the front entrance of the house.

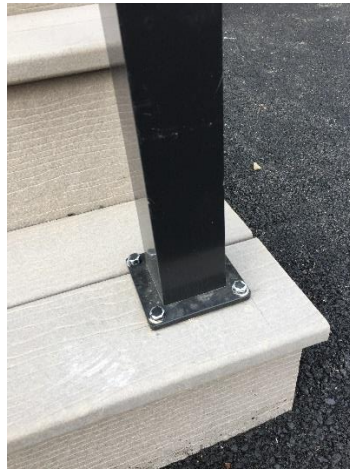
Figure 1

Figure 2 shows how the railing was designed to look finished. Unfortunately, only a few posts have these finished caps. The Railings were bolted properly but don't have the Cosmetic caps installed, so all you see are beat up bolts, as shown on **Figure 1**.

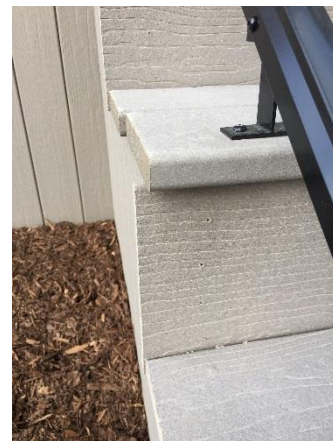
Figure 3 shows that the deck was installed quickly with several careless cuts made. They fastened the decking down with screws, which is ok. The issues with these stairs are mainly cosmetic and rushed.

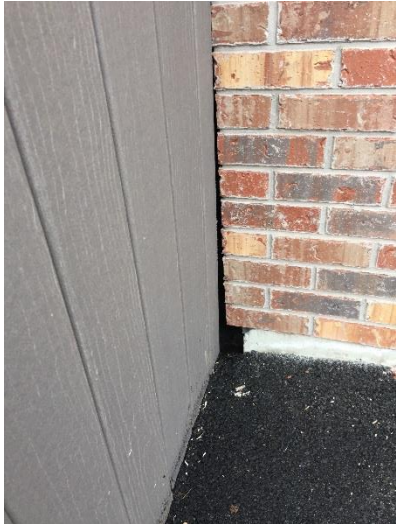
Figure 4

As shown on **Figure 4**, the Composite board that wraps around the exterior of the deck has been pushed in. There is a good chance that the installation of the Asphalt driveway forced the composite decking to be pushed back. When installing an Asphalt driveway, they must roll the Asphalt flat and in doing so, could have forced the skirting back.
